METALLURGICAL EVALUATION OF

COAL BURNER TIP

EMBRITTLEMENT AND EROSION

INTERMOUNTAIN POWER SERVICE CORPORATION

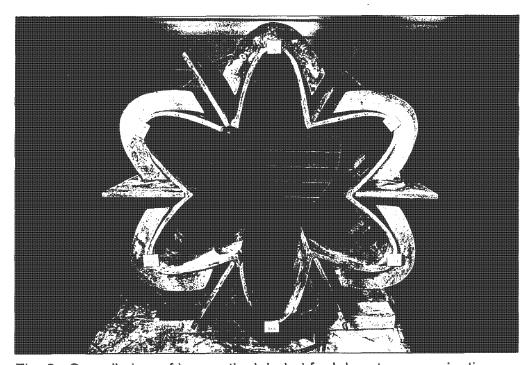
Fig. 2. Overall view of burner tip, labeled for laboratory examination.

The six burner vanes were arbitrarily labeled 0°, 45°, 135°, 180°, 225° and 335° for ease of reference. Overall views of the outside diameter surfaces of the burner tip are shown in Figs. 2 through 4. Visual examination confirmed that there were multiple cracks, both longitudinal and transverse. Furthermore, the cracking had caused a segment of the burner vane labeled 180° to be completely detached from the burner. Visual examination also confirmed that the cracking had initiated at the locations marked 45°, 180° and 335°.

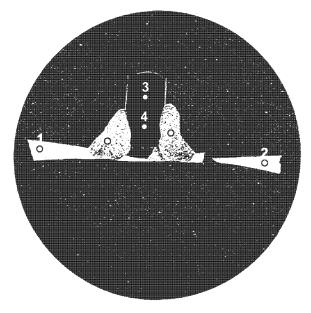
Fig. 10. Overall view of subsegment cut at cross section "A-A".

The subsegment removed at cross section "A-A" through the fracture origin is shown at a magnification of 1X (one diameter) in Fig. 10. Rockwell B and C hardness determinations were made at the locations shown. The corresponding Brinell hardness values, provided in (), ranged from 304 BHN to 307 BHN in the burner, from 186 BHN to 199 BHN in the plate, and from 224 BHN to 229 BHN in the weld. The expected Brinell hardness value for a grade HF casting in the as-cast condition is approximately 200 BHN.

Rockwell B and C hardness determinations are provided below. The corresponding Brinell hardness numbers are shown in ().

Rockwell C Hardness Values

- 1. 32.6 (307)
- 2. 32.3 (304)

Rockwell B Hardness Values

- 3. 88.7 (186)
- 4. 91.5 (199)
- 5. 95.8 (224)
- 6. 96.5 (229)

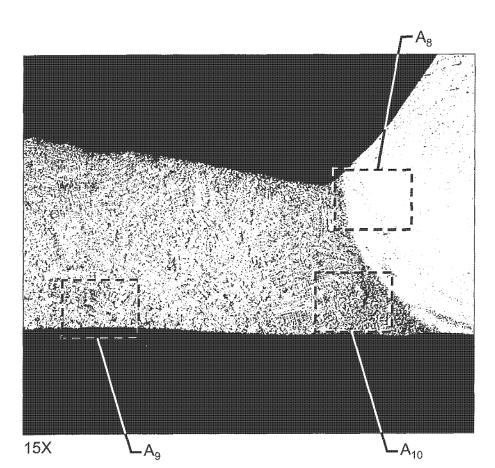
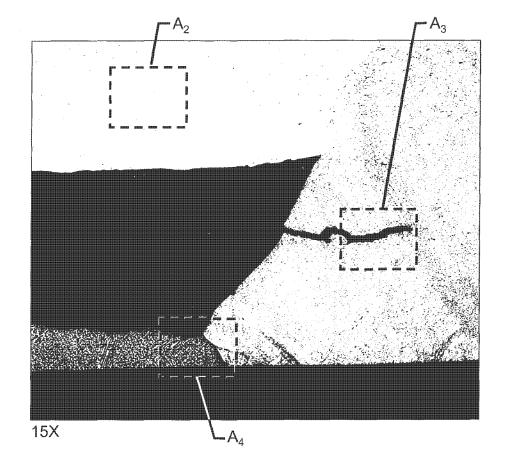
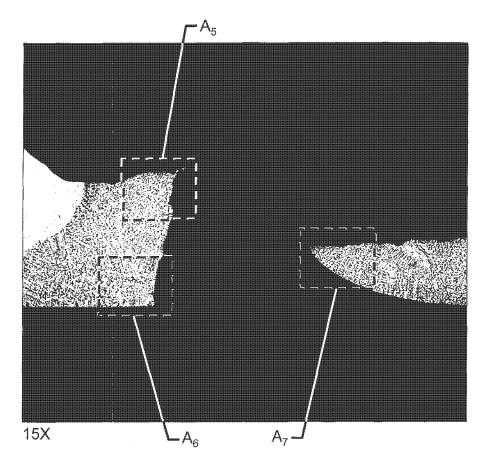
Fig. 11. Photomacrographs of cross section "A-A".

Photomacrographs (magnification 15X) of cross section "A-A" are provided in Fig. 11. Cross section "A-A" was examined comprehensively at higher magnifications and representative areas were selected to document conditions observed. These areas, identified as " A_2 " to " A_{10} ", are indicated on the photomacrographs.

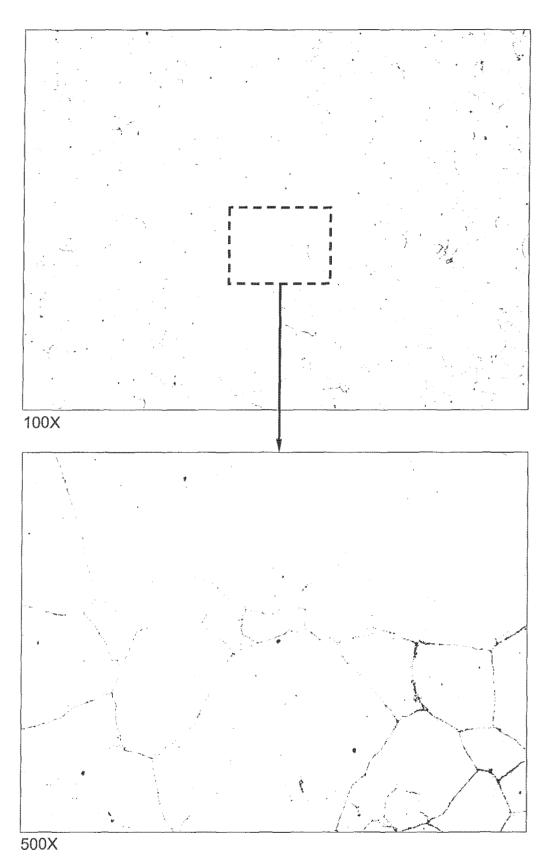
Fig. 12. Microstructure at "A2".

Area "A₂", Fig. 12, was located on the plate that was welded to the burner. The microstructure consisted of austenite grains, typical for austenitic stainless steel.

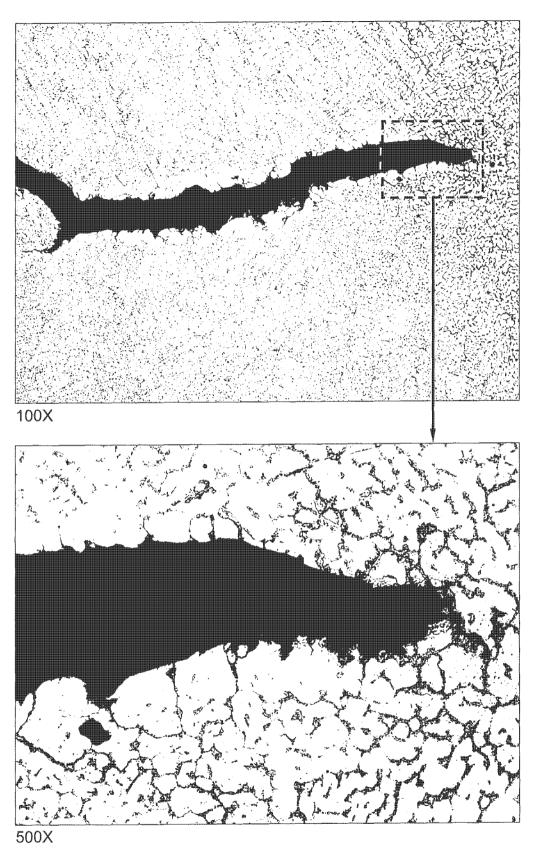
Fig. 13. Microstructure at "A₃".

Area " A_3 ", Fig. 13, was selected to illustrate the cracking observed on the burner-to-plate filet weld. The crack progression was transgranular in nature, indicative of fatigue. Localized recrystallization of the grains at the mating fracture surfaces was observed near the tip of the crack. This suggests that the two fracture surfaces may have come in contact with each other, with the subsequent exposure to elevated temperature causing the observed recrystallization of the grains. The microstructure at area " A_3 " consisted of austenite grains, with a large amount of carbides at the grain boundaries.

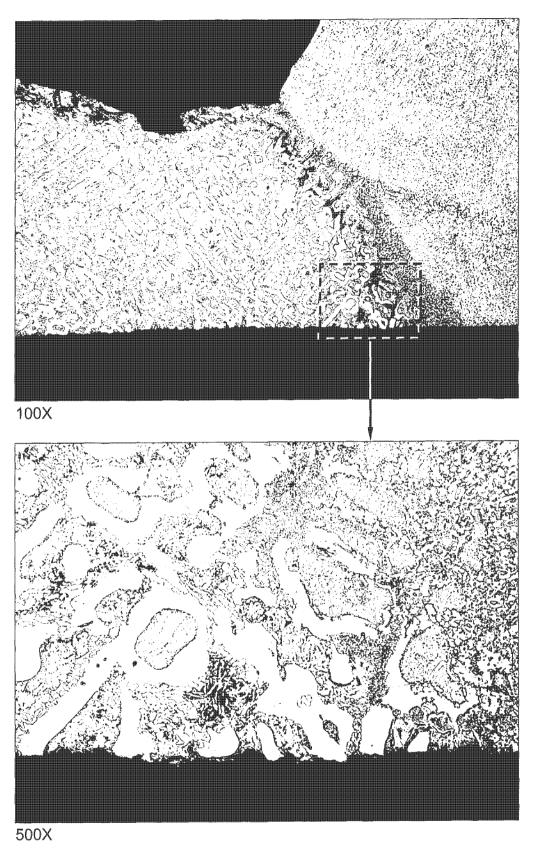
Fig. 14. Microstructure at "A₄".

Area "A₄", Fig. 14, illustrates the microstructure of the burner near the plate-to-burner filet weld. The microstructure in this area was dendritic, consisting of austenite (light matrix) and ferrite with carbide islands. Casting defects such as porosity, shrinkage voids or hot tears were not observed.

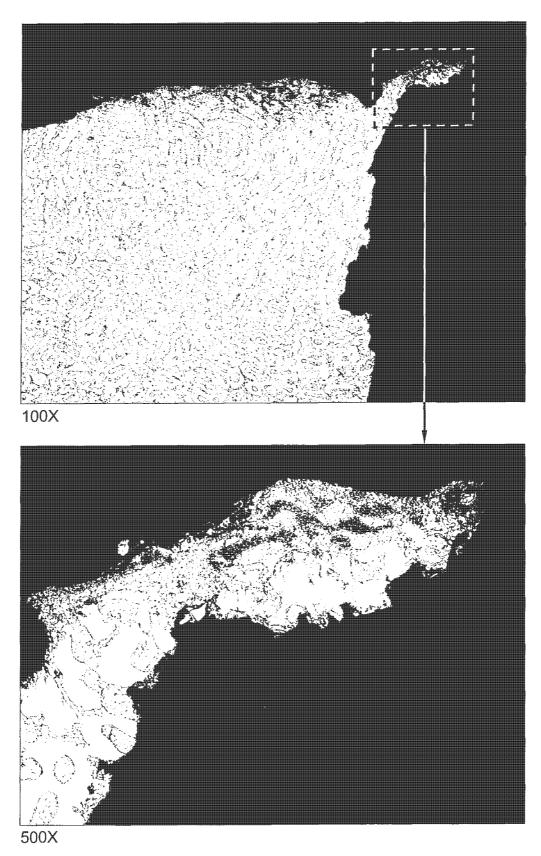
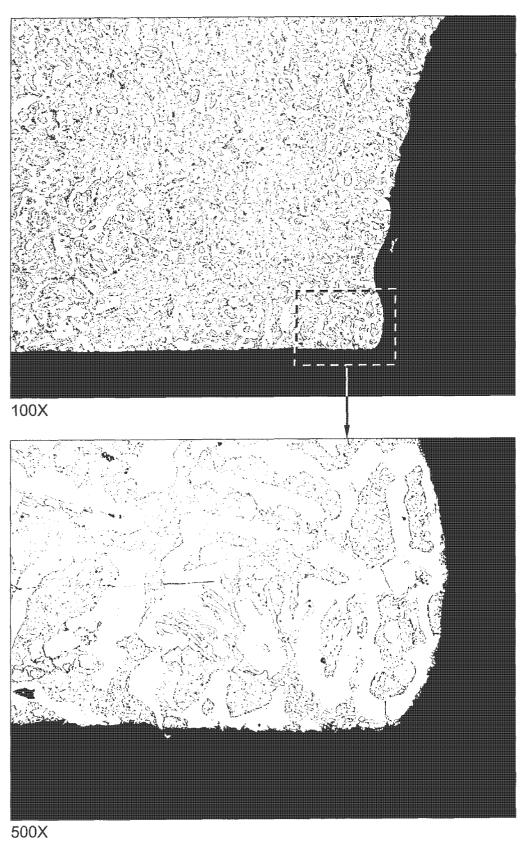
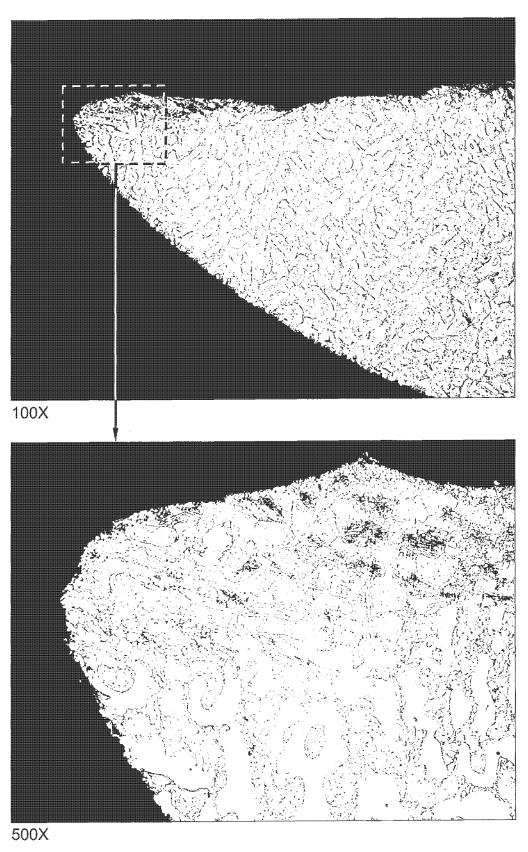
Areas " A_5 " through " A_7 ", Figs. 15 through 17, respectively, illustrate the microstructure at the fracture surfaces. The fracture surfaces at and near the inside diameter of the burner were smooth and rounded, most likely due to erosion. Some localized cold work was observed near the outside diameter surfaces. Again the microstructure consisted of austenite (light matrix) and ferrite with carbide islands. Casting defects such as porosity, shrinkage voids or hot tears were not observed.

Fig. 15. Microstructure at " A_5 ".

Fig. 16. Microstructure at " A_6 ".

Fig. 17. Microstructure at "A₇".

The visual examination of the failed burner confirmed that the fracture was brittle in nature; plastic deformation was not observed on any of the fracture surfaces. The brittle nature of the fracture was further confirmed by optical microscopy. While some cold work was detected, there was no evidence of plastic deformation. Moreover, optical microscopy revealed nearly continuous carbide and sigma phase precipitation. The higher hardness readings recorded on the burner provide additional evidence of embrittlement.

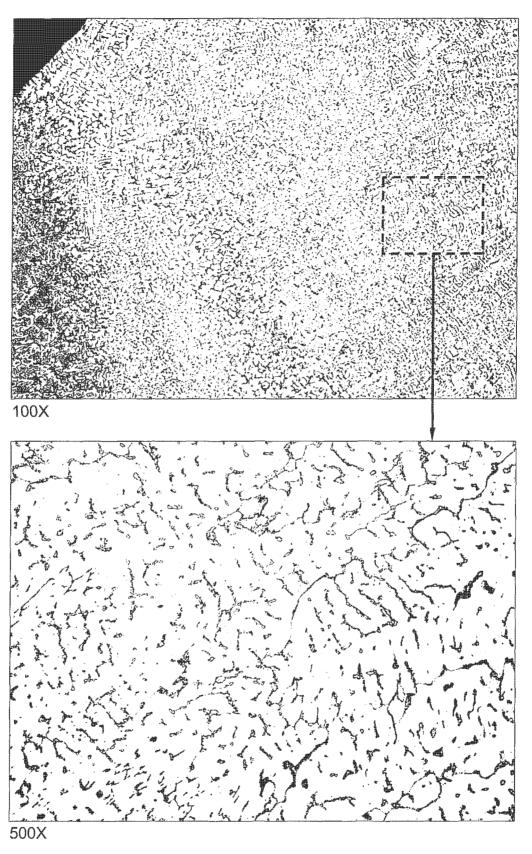
Fig. 18. Microstructure at "A₈".

Area "A₈", Fig. 18, illustrates the other fillet weld in cross section "A-A". The microstructure observed in this area was similar to that at "A₈" and similar comments apply.

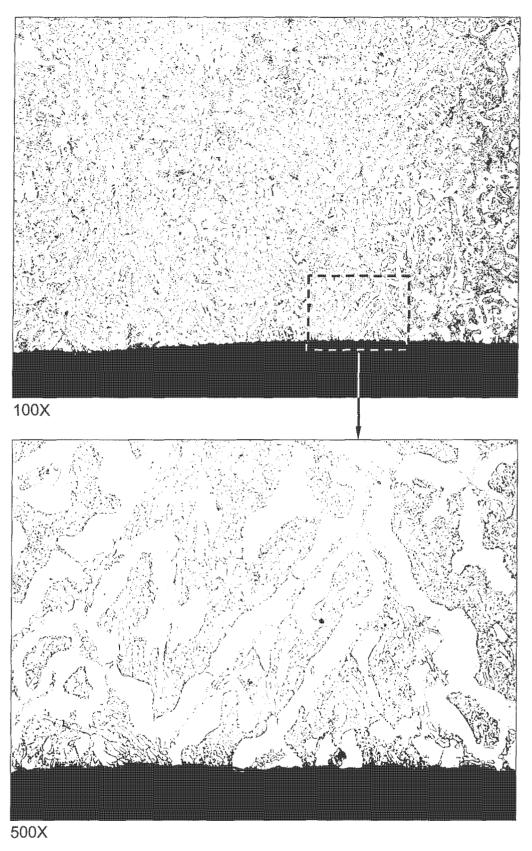
Fig. 19. Microstructure at "A₉".

Area "A₉", Fig. 19, illustrates the inside diameter surface of the burner away from the fracture. The microstructure consisted of austenite (light matrix) and ferrite with carbide islands. Casting defects such as porosity, shrinkage voids or hot tears were not observed.

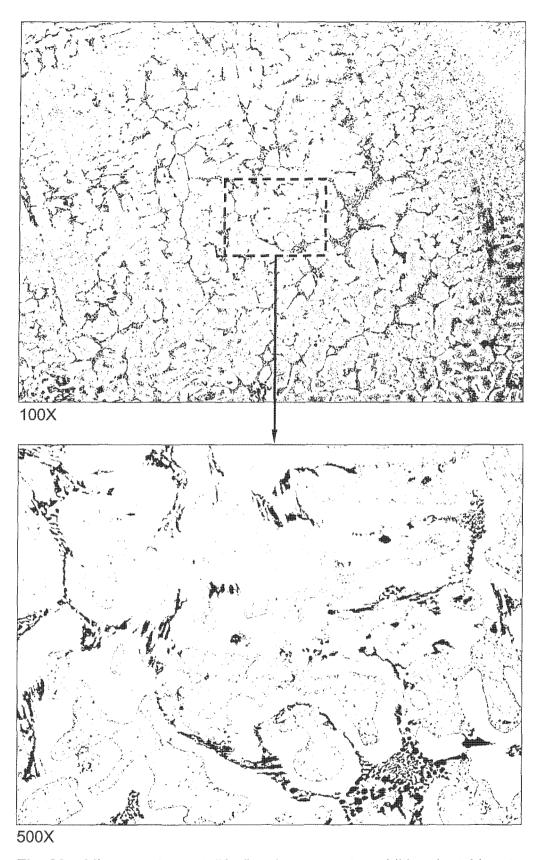
Fig. 20. Microstructure at "A₁₀" subsequent to additional etching to delineate carbides and sigma phase.

Cross section "A-A" was re-etched with a solution of sodium cyanide in an effort to delineate any possible carbides and/or sigma phase precipitates. The cross section was examined comprehensively by optical microscopy. Area "A₁₀", shown in Fig. 20, was selected to illustrate the observed precipitates (dark areas).

Iron-chromium-nickel alloys are susceptible to considerable hardening which can result in severe loss of ductility (embrittlement) after prolonged exposure to elevated temperatures. This embrittlement is caused by carbide precipitation and agglomeration at the grain boundaries as well as sigma phase precipitation.

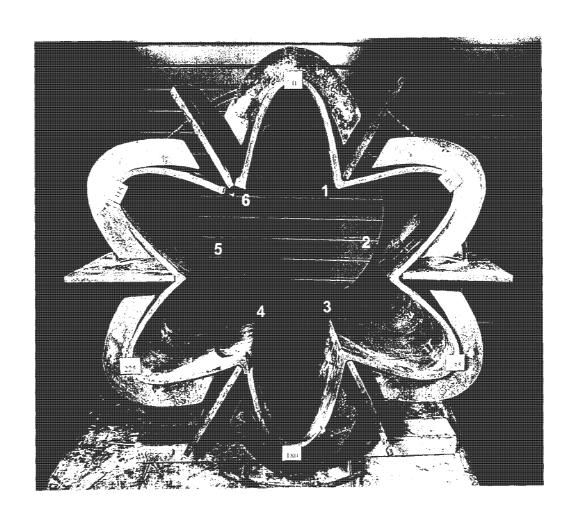
WALL THICKNESS MEASUREMENTS

The results of the dimensional measurements confirmed that the erosion wear observed was highly localized. The wall thickness values at locations Nos. 1, 2, 3, 4 and 6 ranged from 0.081" to 0.145", a reduction of 62% to 79% from the reported nominal thickness of 0.375". The wall thickness value recorded at location No. 5 was 0.418", or 11% greater than the reported nominal thickness. Furthermore, thickness readings recorded 2" above and 2" below the wear areas did not reveal significant wear.

LOCATION	WEAR AREA	2" ABOVE	2" BELOW
1.	0.081"	0.383"	0.256"
2.	0.112"	0.407"	0.381"
3.	0.090"	0.352"	0.382"
4.	0.111"	0.393"	0.446"
5.	0.418"	0.435"	0.410"
6.	0.145"	0.327"	0.294"
